TP 7423

EVALUATION OF SELECTED CONTAINERS
USED FOR
THE SHIPMENT OF DANGEROUS GOODS

DECEMBER 31, 1985

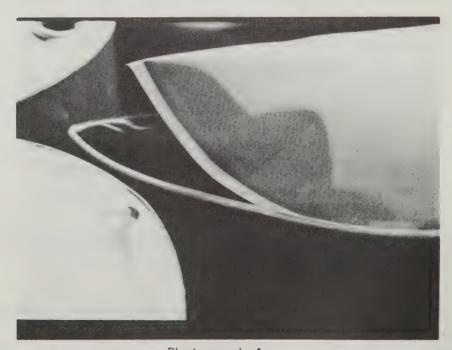
Photograph 4

A tear is defined as a metal fracture observed as a major rupture in which the broken edges are separated, leaving wide gaps.

Major metal tear of 208L drum after drop testing

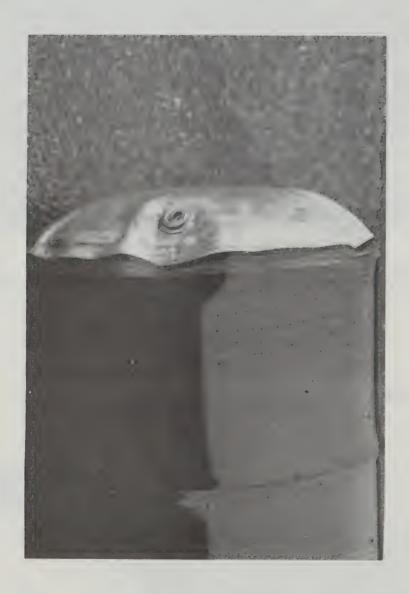
Photograph 5 Typical 208L drum appearance after hydrostatic testing

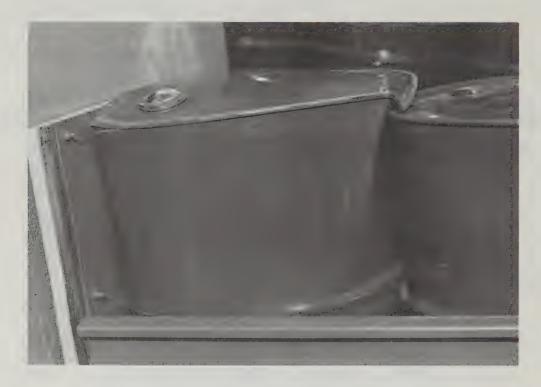
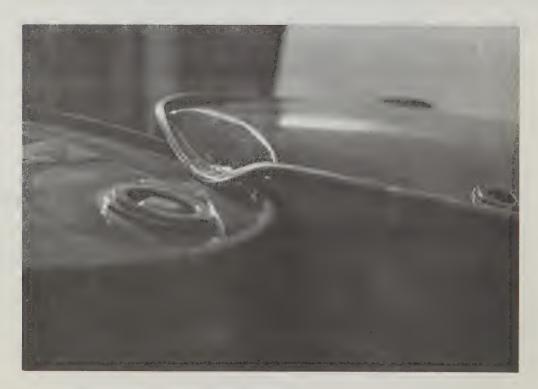
All failures occurred during simulated rail switching and at the top drum chime.

Phtographs 6 and 7 - 208L drums after the third impact of an A.S.T.M. D4169, level 1 simulated rail shunting test

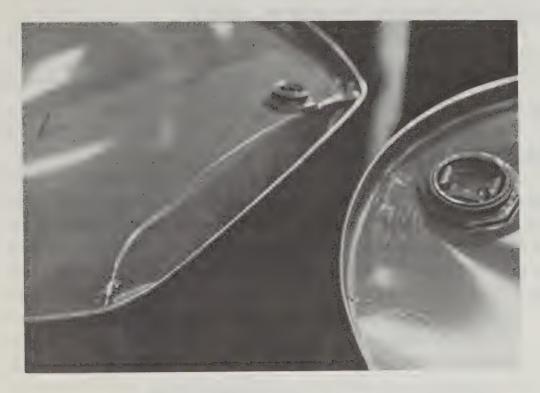
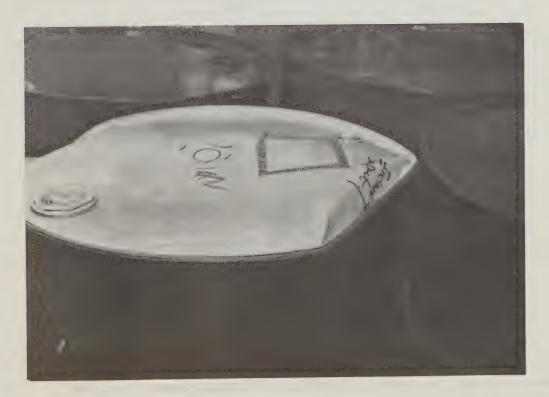
Photographs 8 and 9 - Leading edges of 208L drums after completion of A.S.T.M. D4169, simulated rail shunting at level 2.

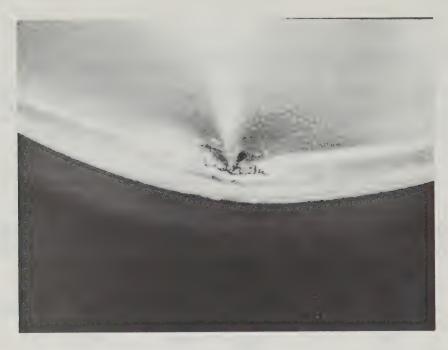
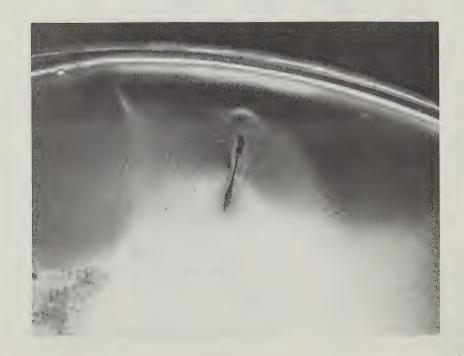
Photographs 10 and 11 - Typical failures on 20L pail bottom after level 1, A.S.T.M. vibration elements

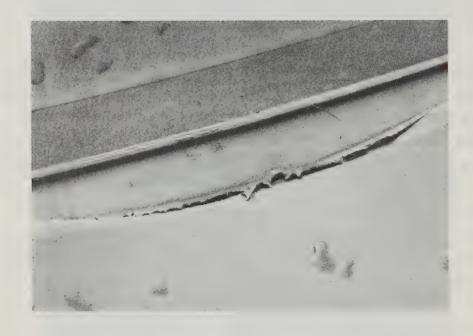
Photograph 12

Failures tended to be parallel to the mold part line but not directly on the line (see Photograph 12). On four top drop failures, cracks around the chime were also observed in conjunction with cracks along the part line.

Typical failure across bottom of a 208L plastic drum after drop testing
